TRANSPORTATION RESEARCH CENTER

ON-SITE AIR BAG INVESTIGATION

CASE NO. - 95-06

This report concerns a motor vehicle crash involving an air bag equipped 1990 Lincoln Continental, 4-door sedan and a 1993 Chevrolet, G-20 (3/4 ton), 4x2, conversion van occurring on [REDACTED], [REDACTED] 1995 at 5:25 p.m., in [REDACTED], Indiana on a [REDACTED]. This crash is of special interest because the case vehicle's deploying driver side air bag caused fatal injuries to the case vehicle's driver.

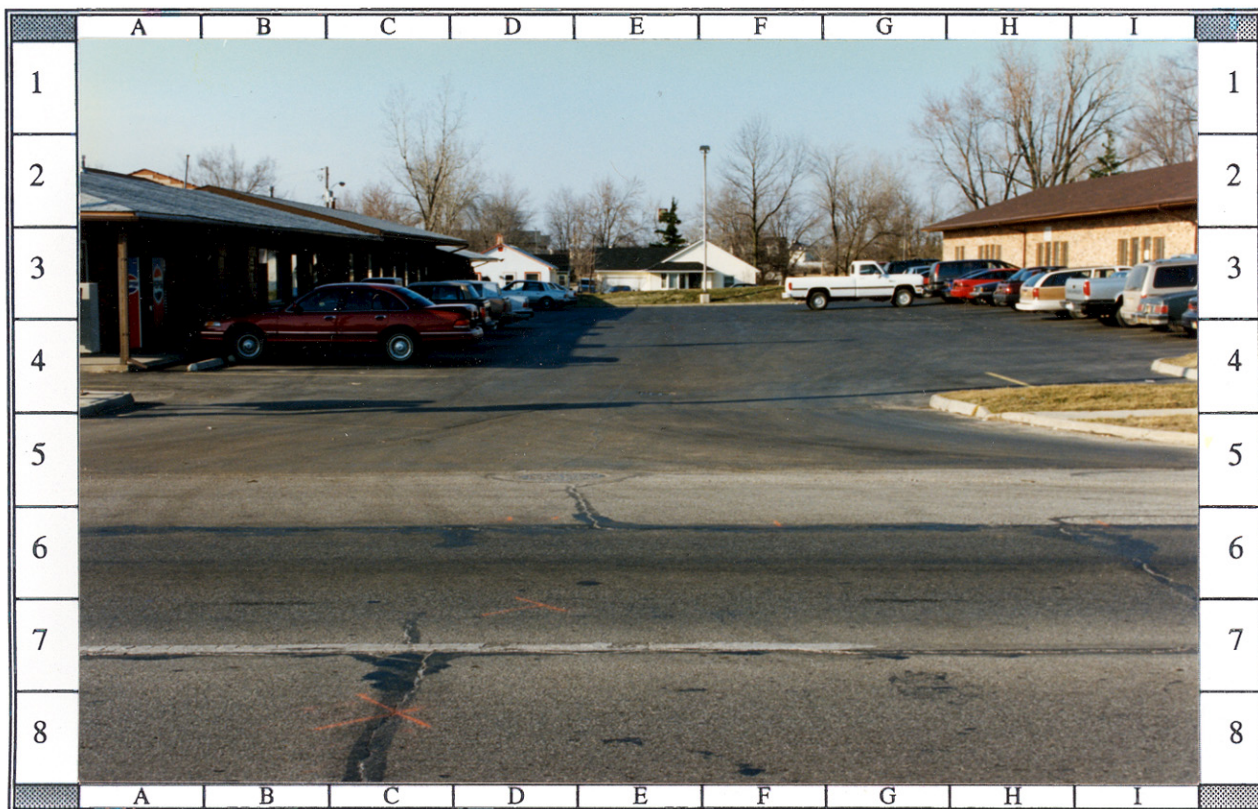
19 -- Northward view of FRP scene marking symbols representing the '93 Chevrolet C-20 van's rear wheels [cells C8 (RR) & D7 (LR)]

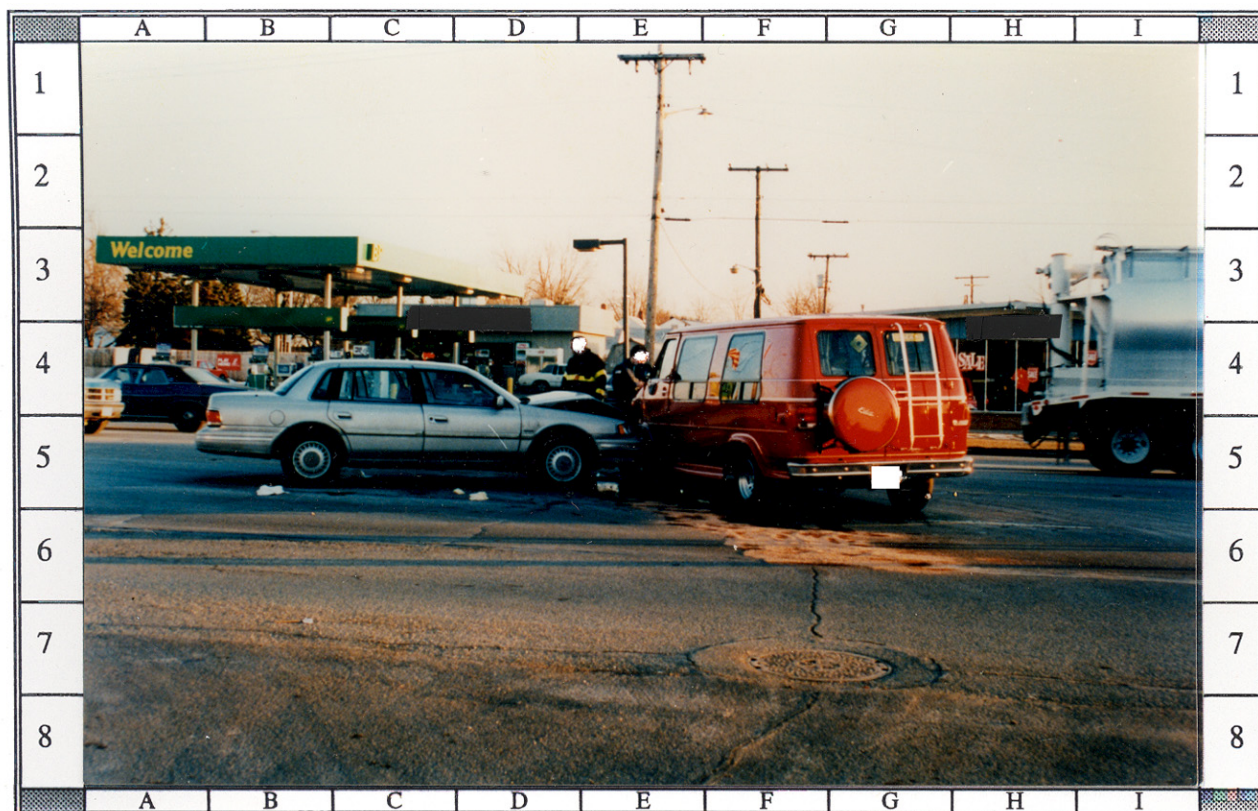
20 -- On-scene southward view of 1990 Lincoln Continental and 1993 Chevrolet C-20 conversion van at final rest

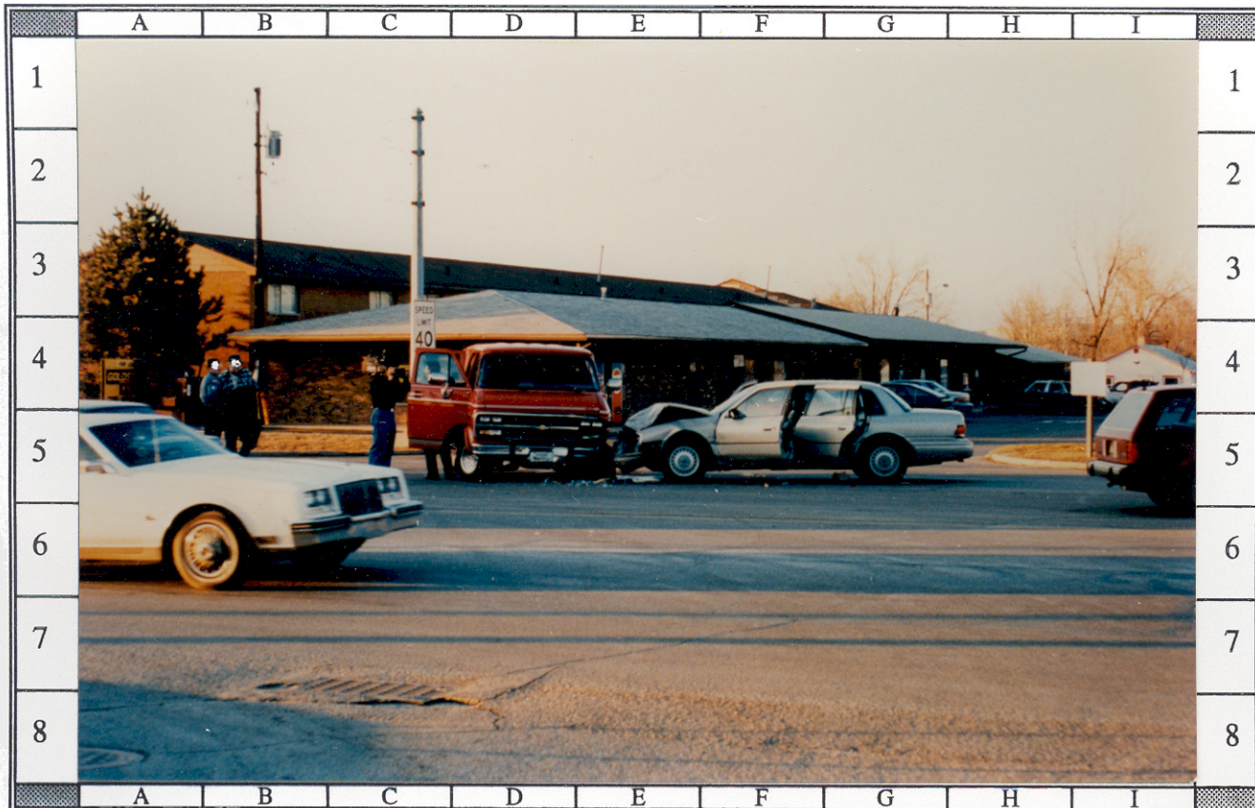
21 -- On-scene south-southeast close-up of front damage to '90 Lincoln Continental and side damage to '93 Chevrolet C-20 conversion van

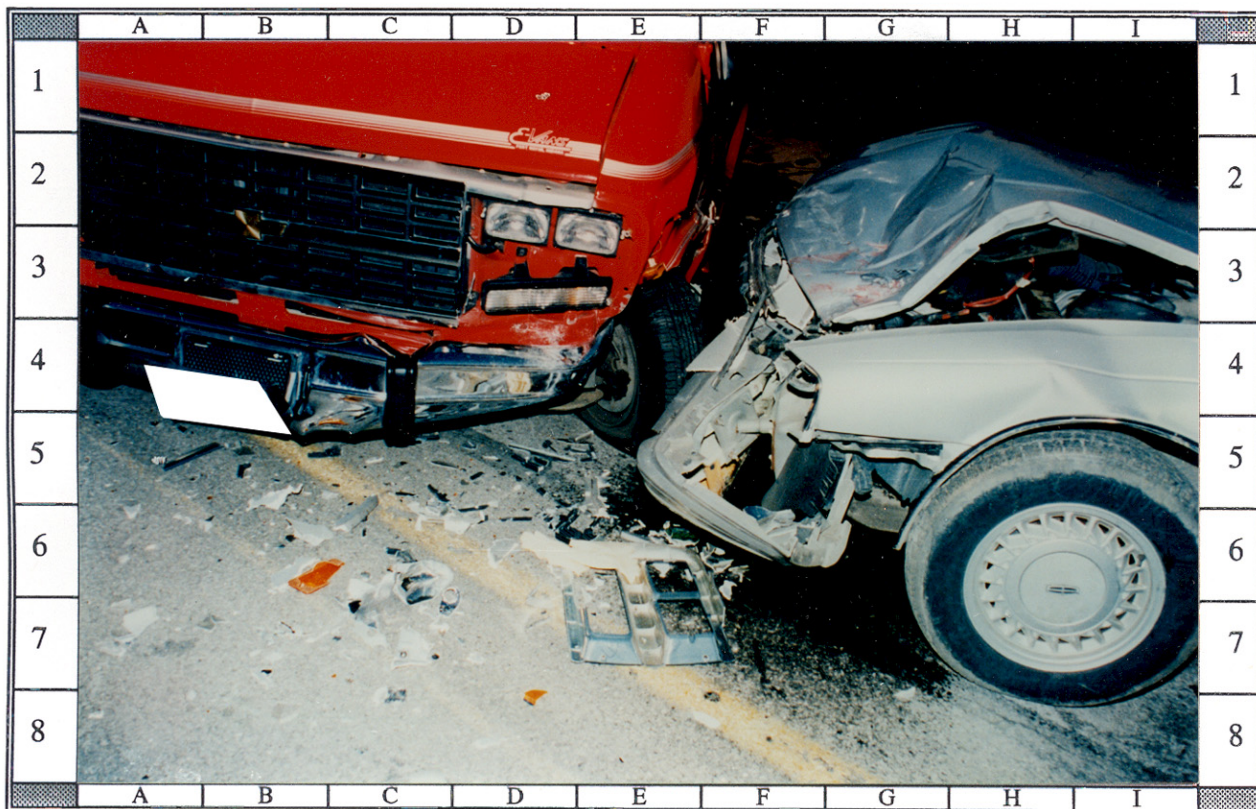
22 -- On-scene north-northwest view of 1990 Lincoln Continental & 1993 Chevrolet C-20 conversion van at final rest

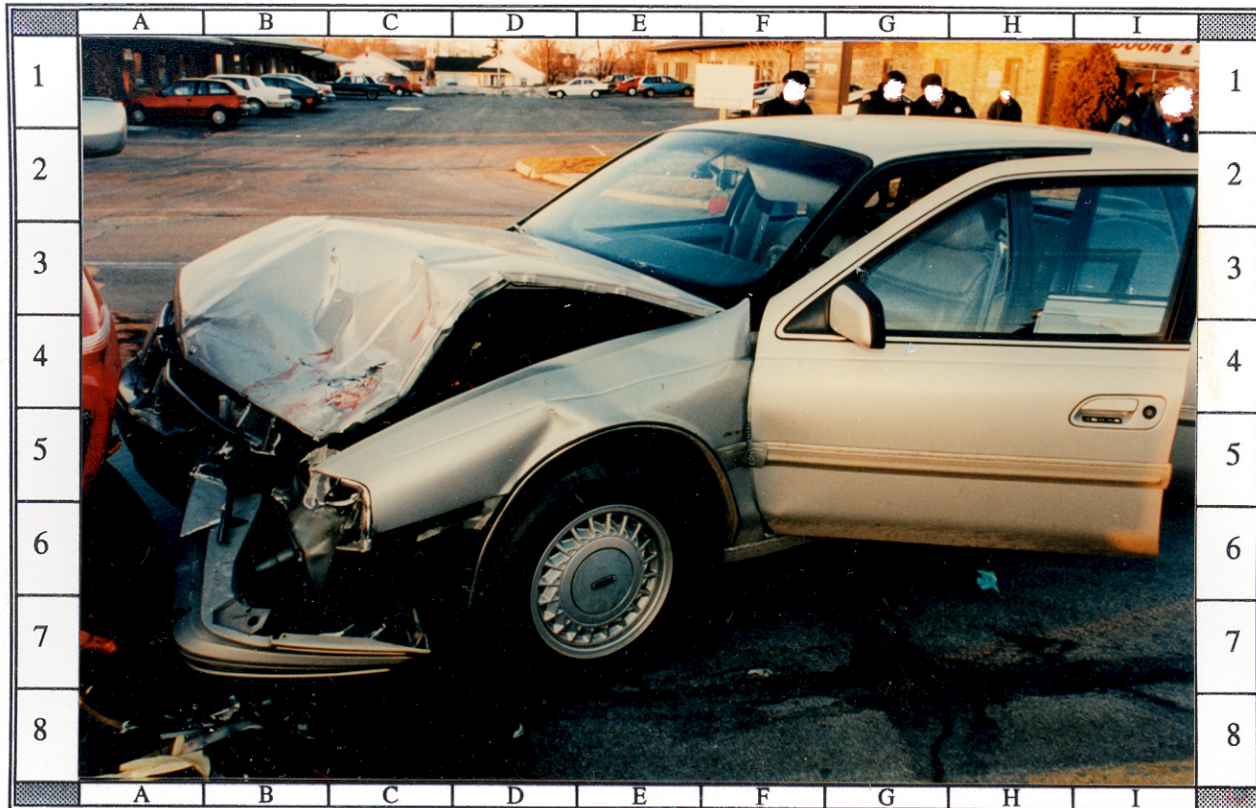
23 -- On-scene north-northwest close-up of frontal damage to both the 1990 Lincoln Continental and 1993 Chevrolet conversion van

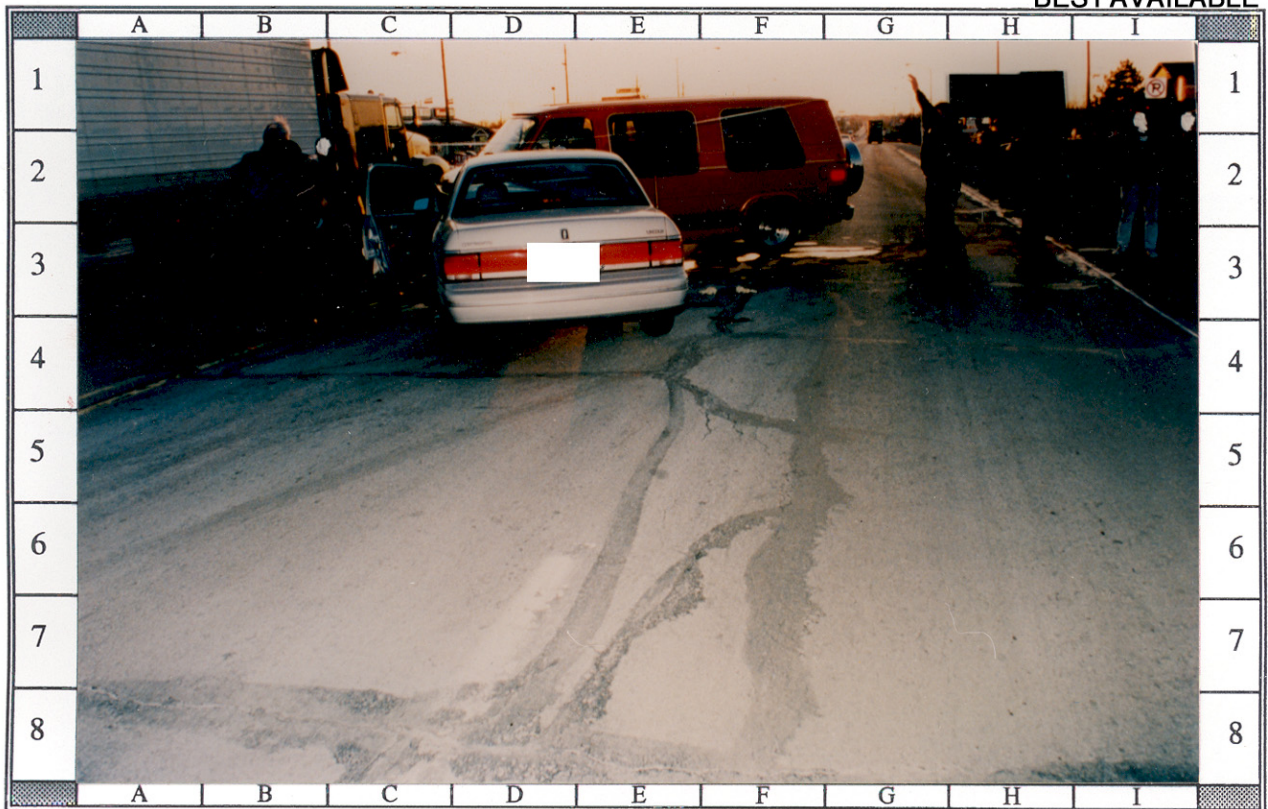
24 -- On-scene northward close-up of 1990 Lincoln Continental's front damage; NOTE: area of initial bumper contact (cell A5)

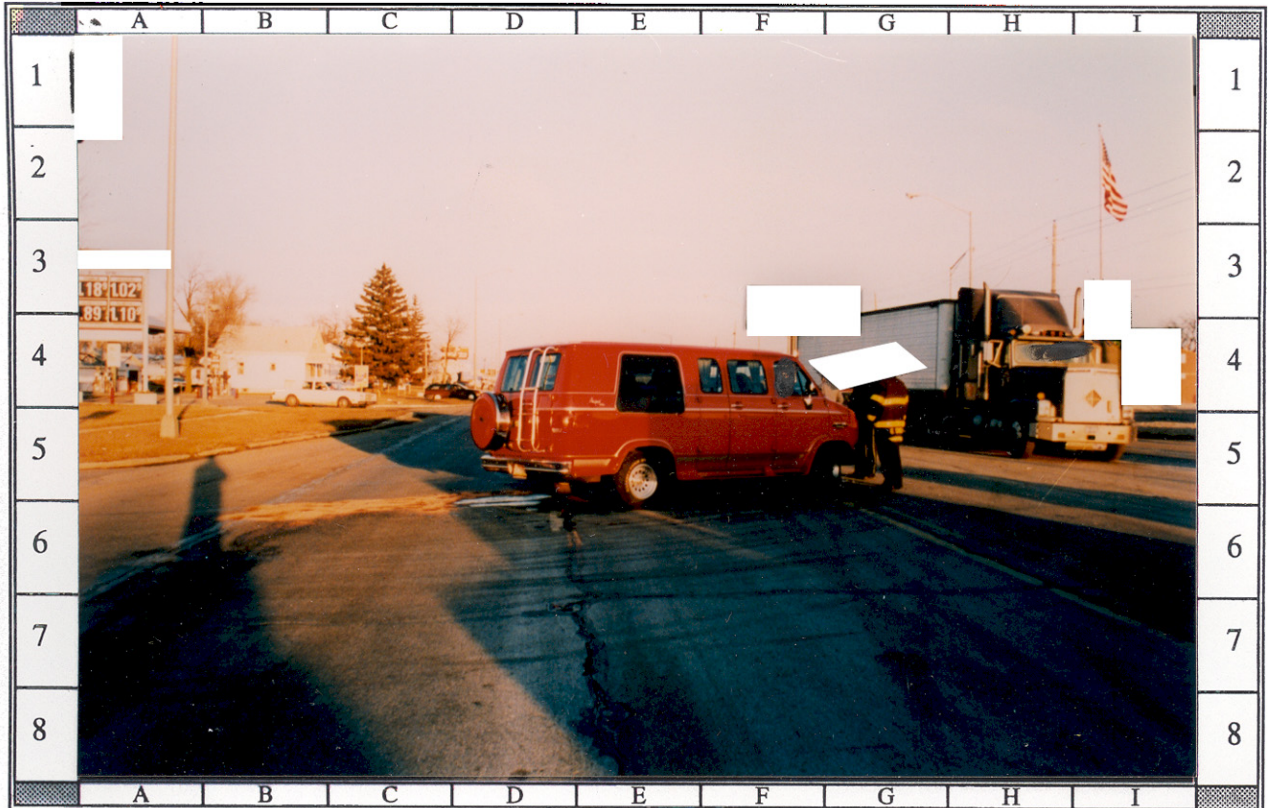
26 -- On-scene eastward view of 1993 Chevrolet C-20 conversion van at final rest--from north side of inside westbound lane

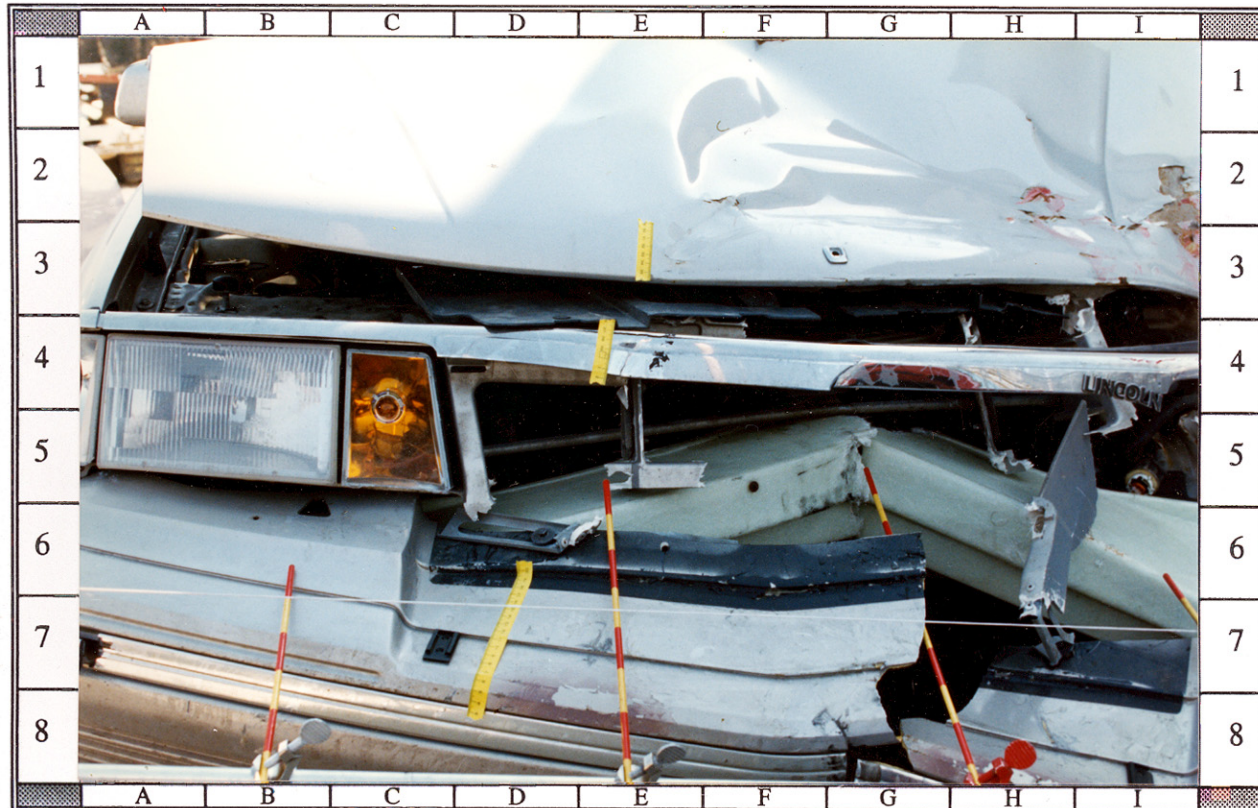
27 -- Right reference line view of 1990 Lincoln Continental's frontal damage--contour gauge @ bumper level; NOTE: red paint on hood

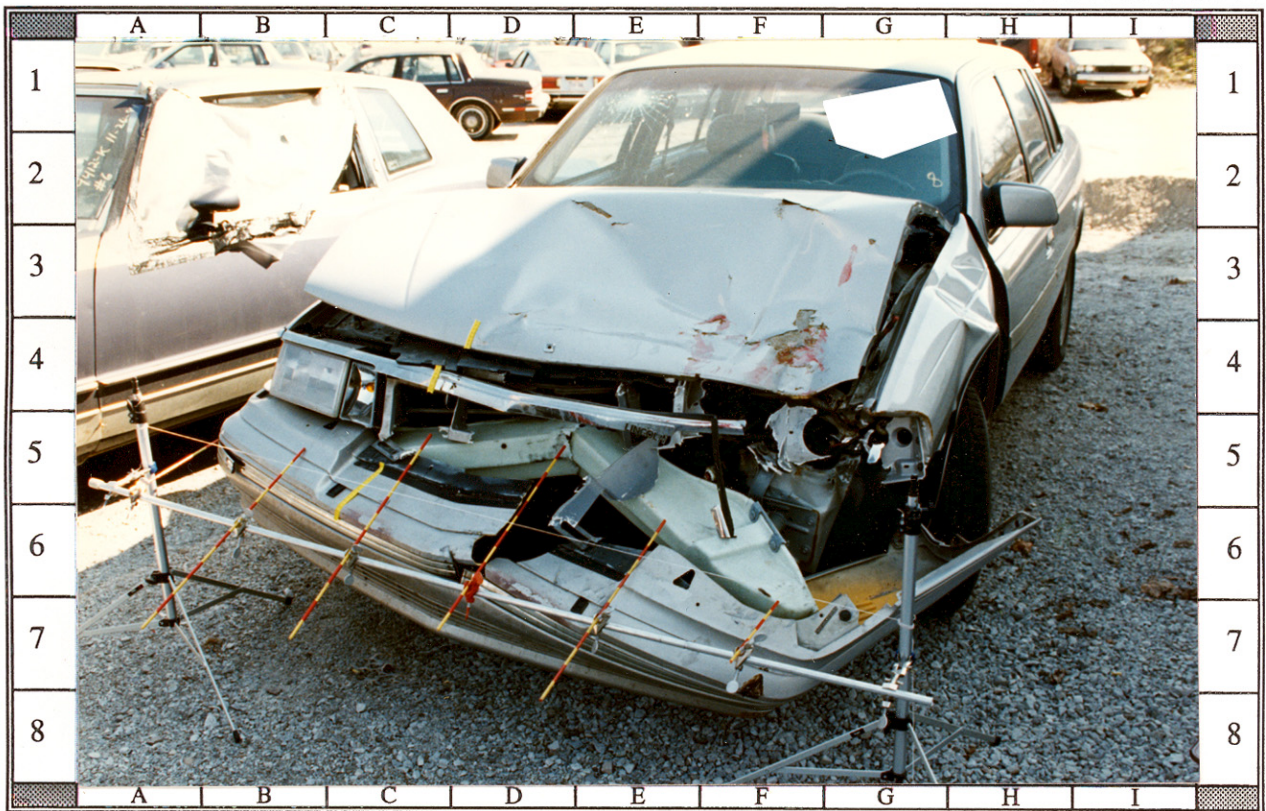
28 -- Close-up of 1990 Lincoln Continental's front damage; NOTE: yellow tape marks beginning of direct damage--R corner not involved

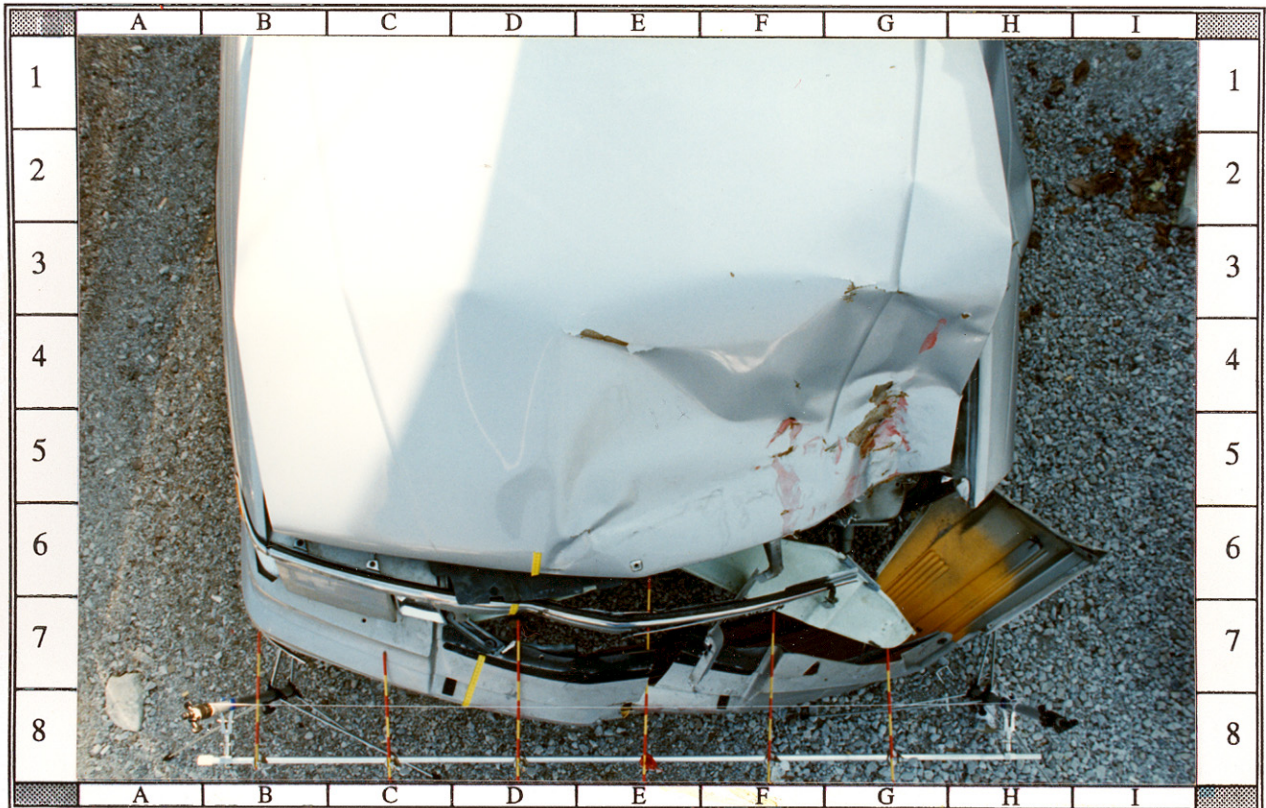
29 -- 1990 Lincoln Continental's damaged front from ~ 15 degrees L of front--contour gauge @ bumper level; max crush @ C₃ (cell D5)

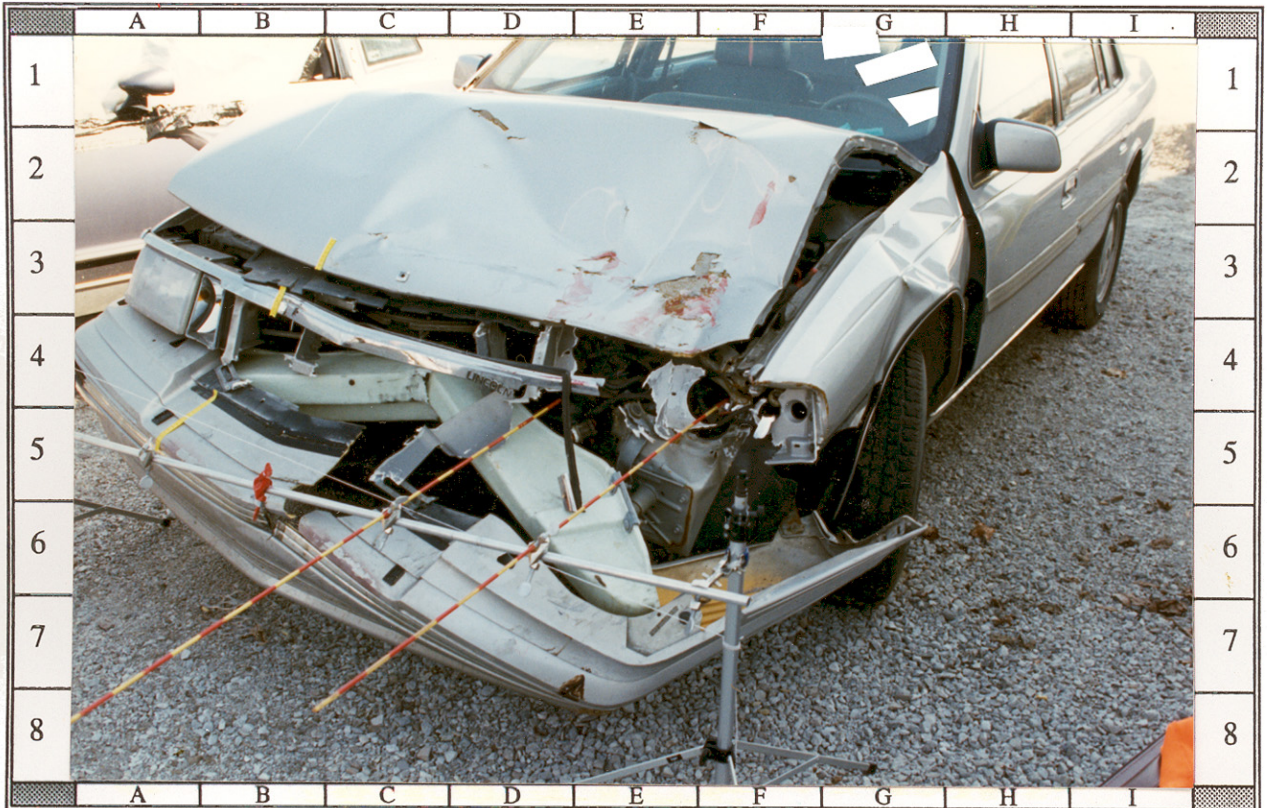
31 -- 1990 Lincoln Continental's front damage @ C₁ & C₂--contour gauge above bumper; NOTE: red hood paint & induced damage to L fender

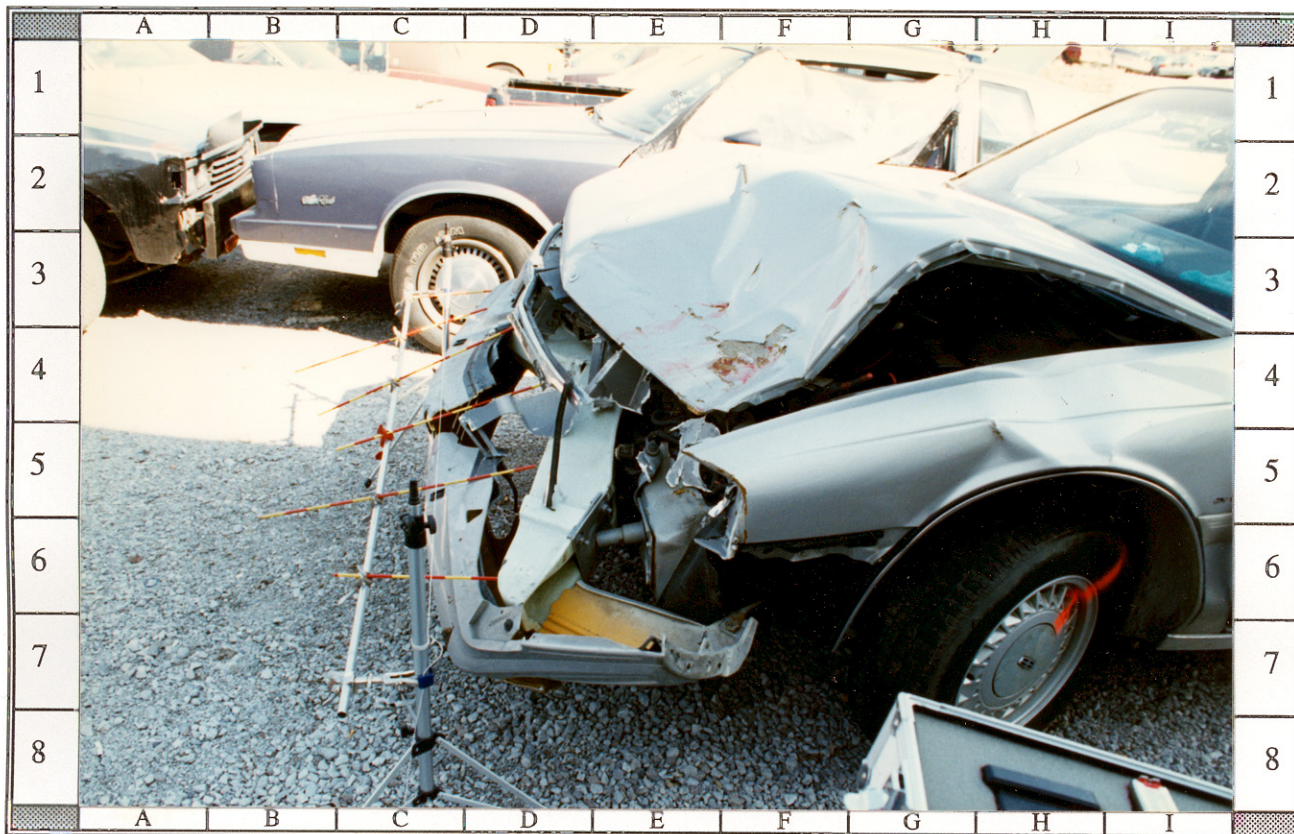
32 -- Close-up view of 1990 Lincoln Continental's front damage @ C₁ & C₂ from ~ 30 degrees left of front--contour gauge above bumper

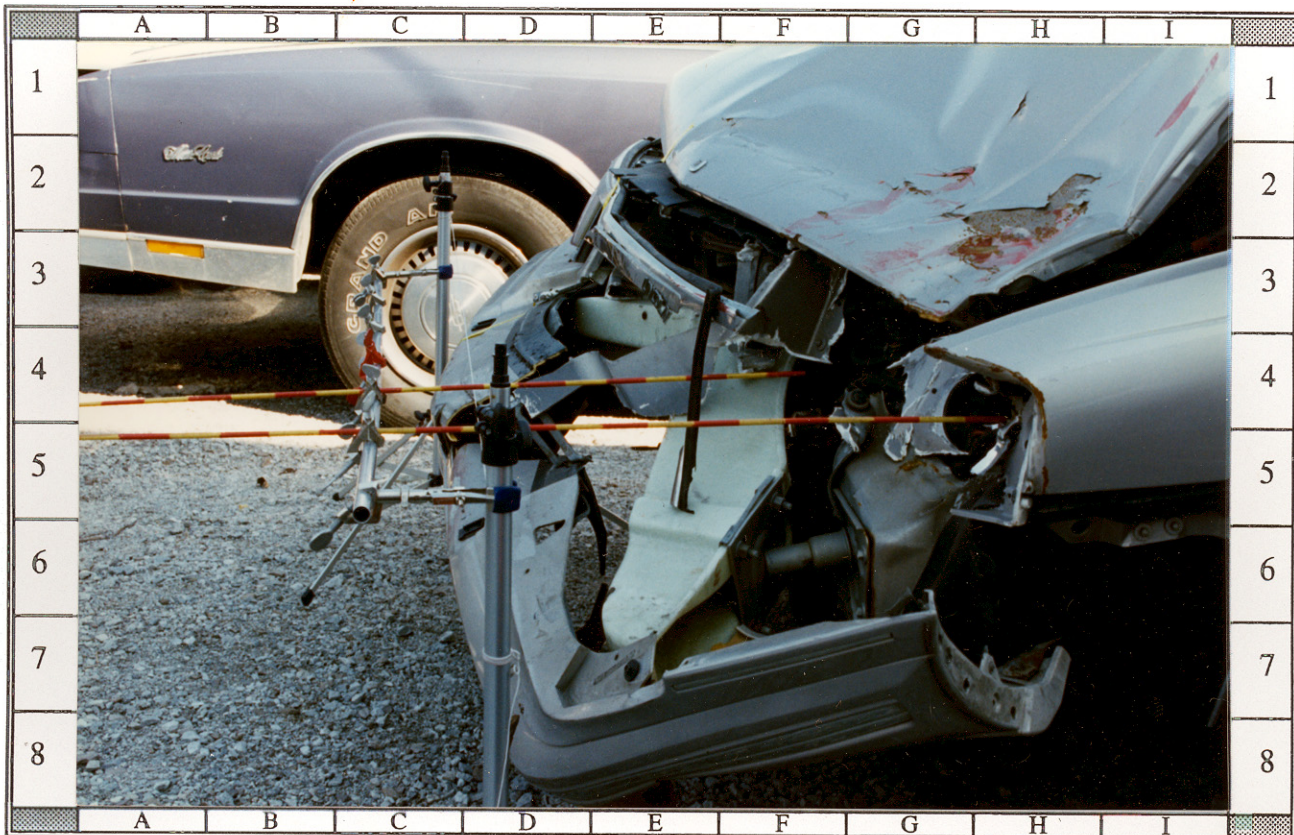
33 -- Front reference line view of 1990 Lincoln Continental's frontal damage--contour gauge @ bumper level; NOTE: red paint on hood

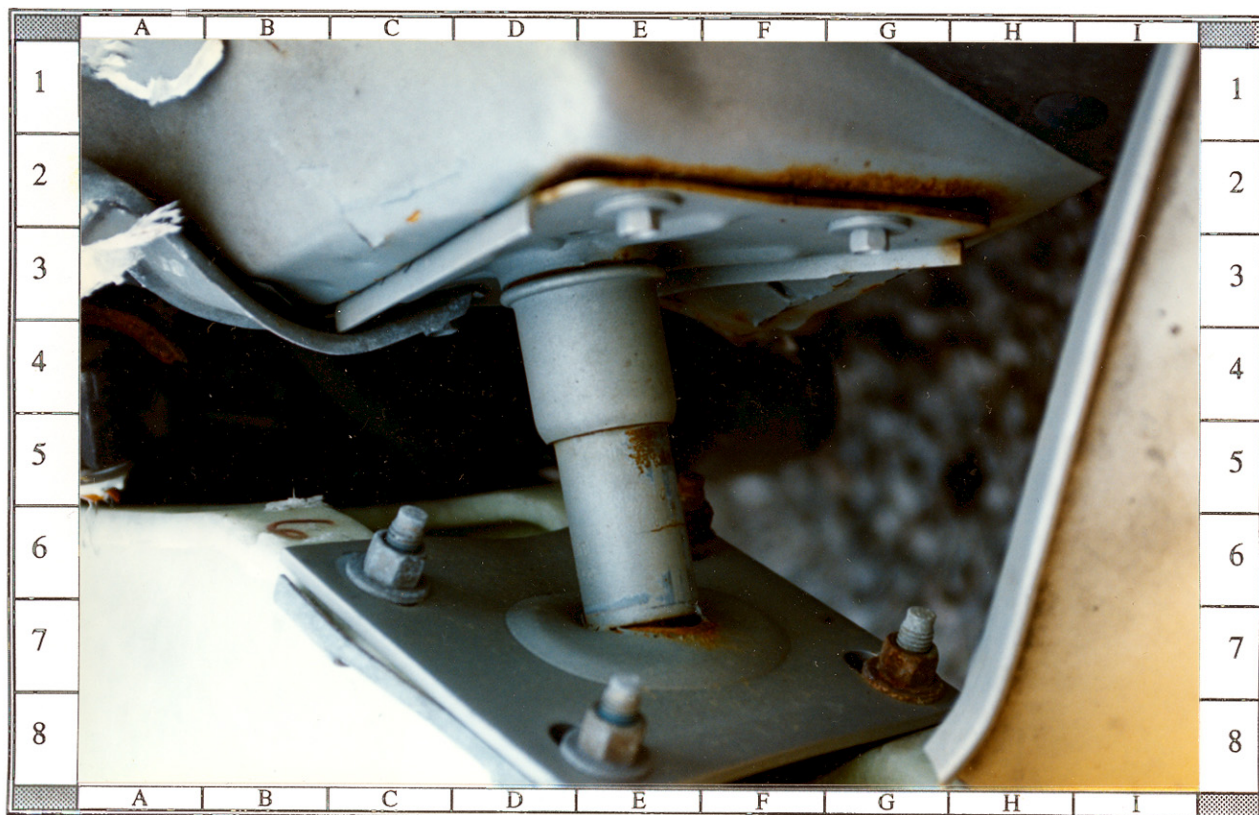
34 -- Close-up front reference line view of 1990 Lincoln Continental's front damage @ C₁ & C₂--contour gauge above bumper

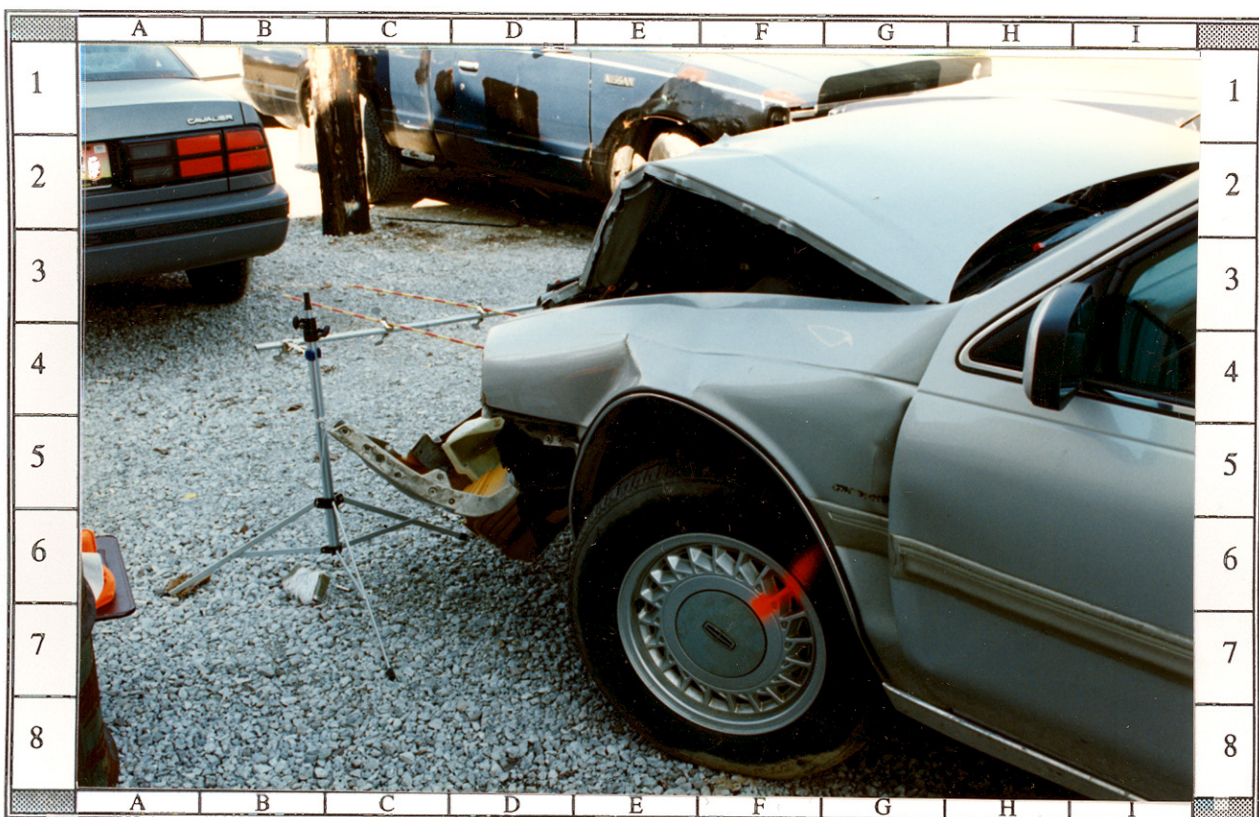
35 -- Close-up of 1990 Lincoln Continental's front left EAD showing complete stroke movement from crash with 1993 Chevrolet C-20 van

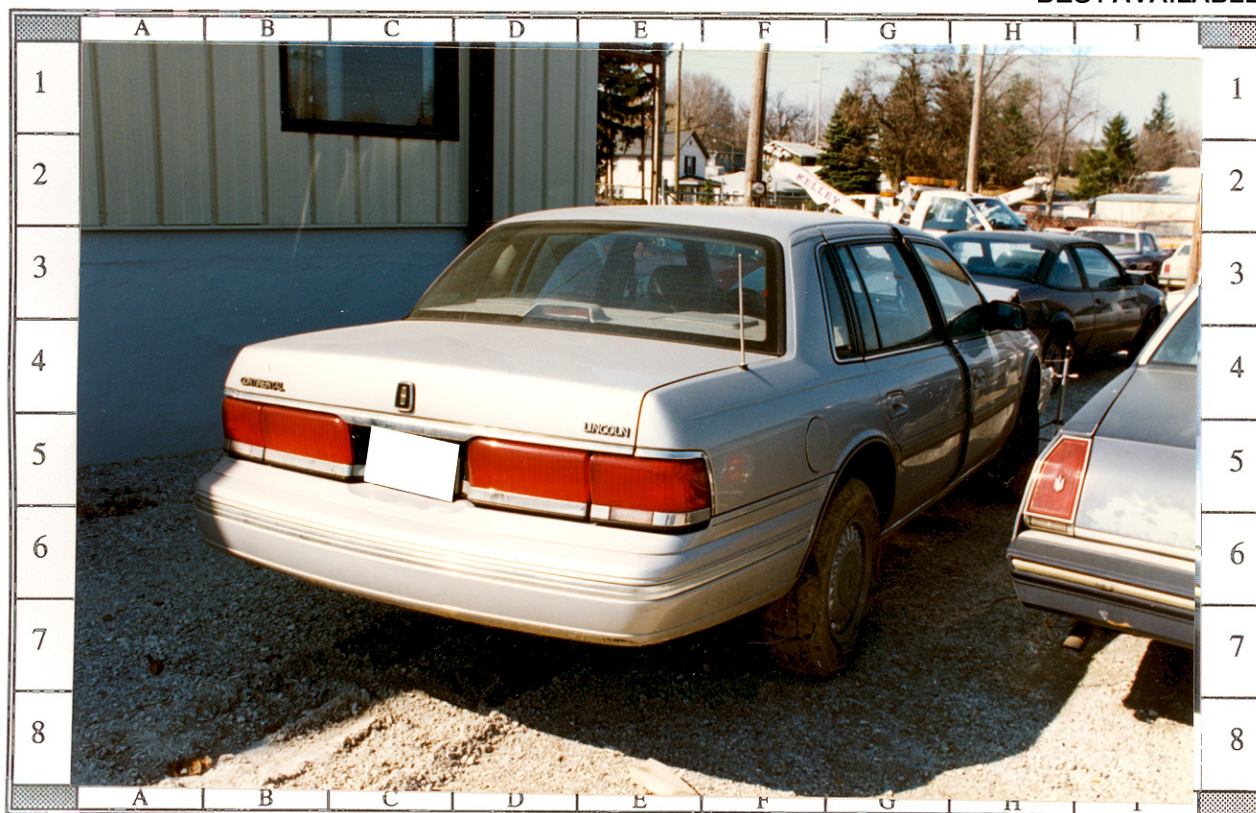
39 -- 1990 Lincoln Continental's right side and undamaged back from ~ 30 degrees right of back

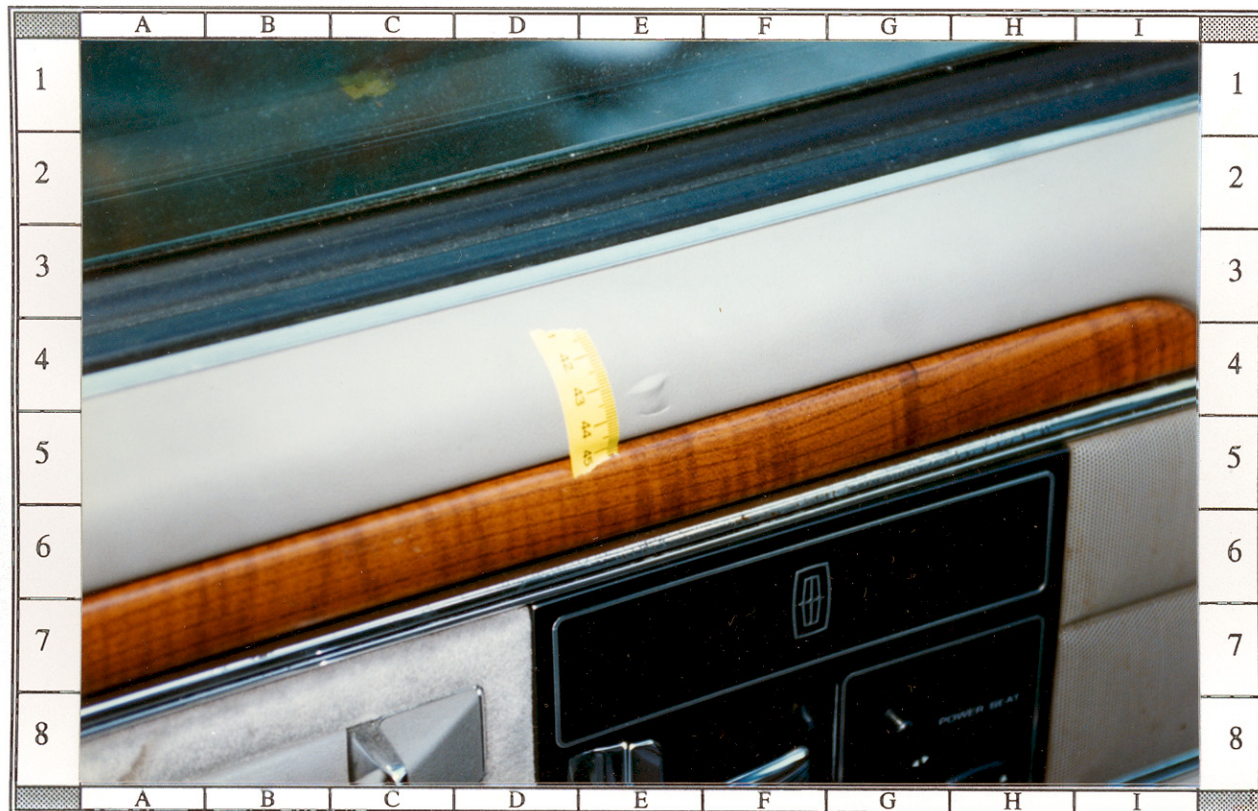
42 -- Close-up of 1990 Lincoln Continental's driver door showing crease at top of door's interior surface

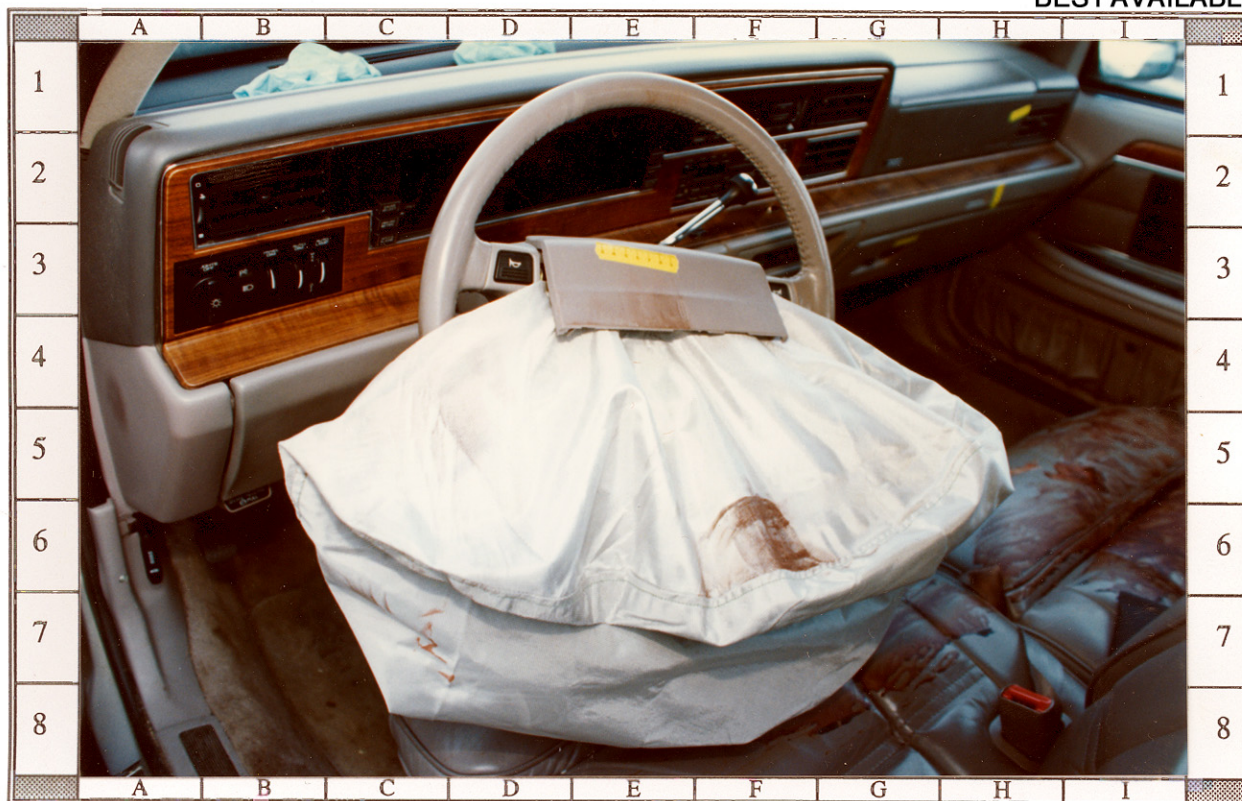
43 -- Close-up of 1990 Lincoln Continental's top cover flap & air bag;
NOTE: blood on flap (cell E3) and air bag (cells C7 and F6)

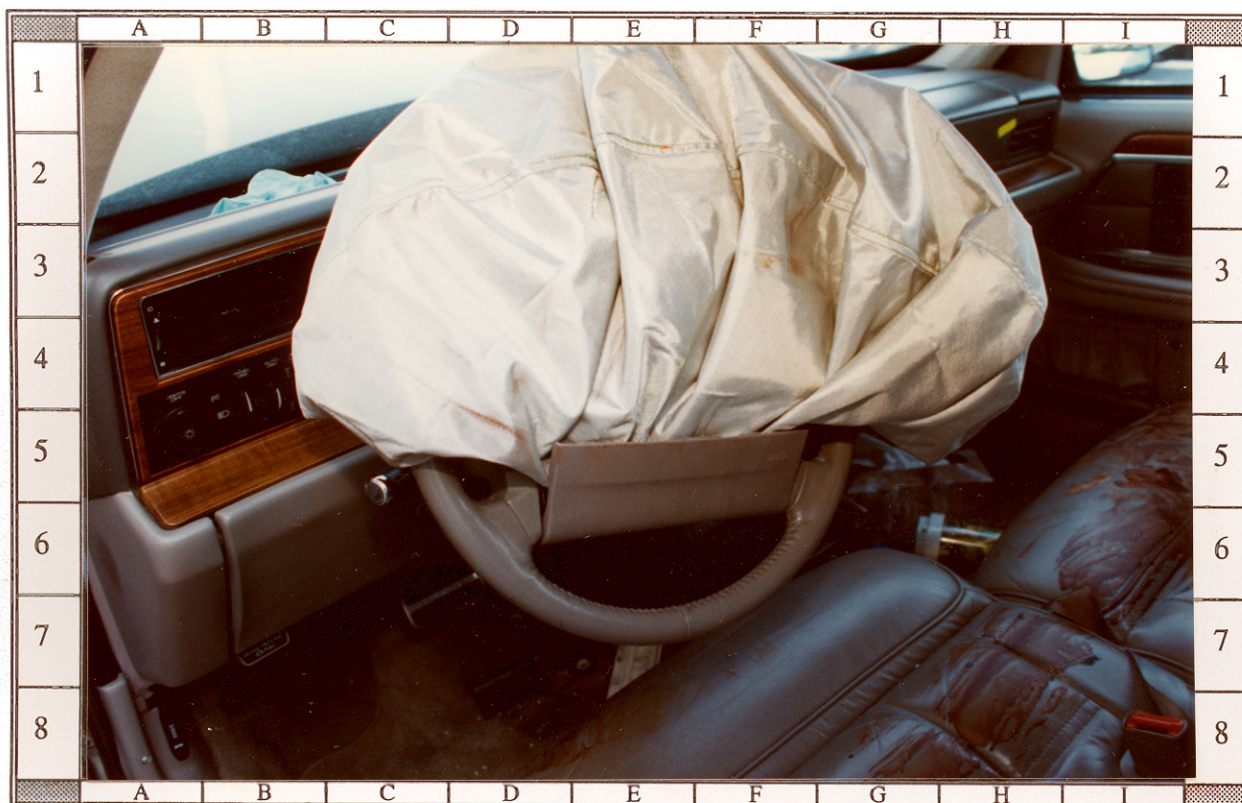
44 -- Close-up of 1990 Lincoln Continental's bottom cover flap and air bag;
NOTE: blood on seats and contact to right dash (cell H1)

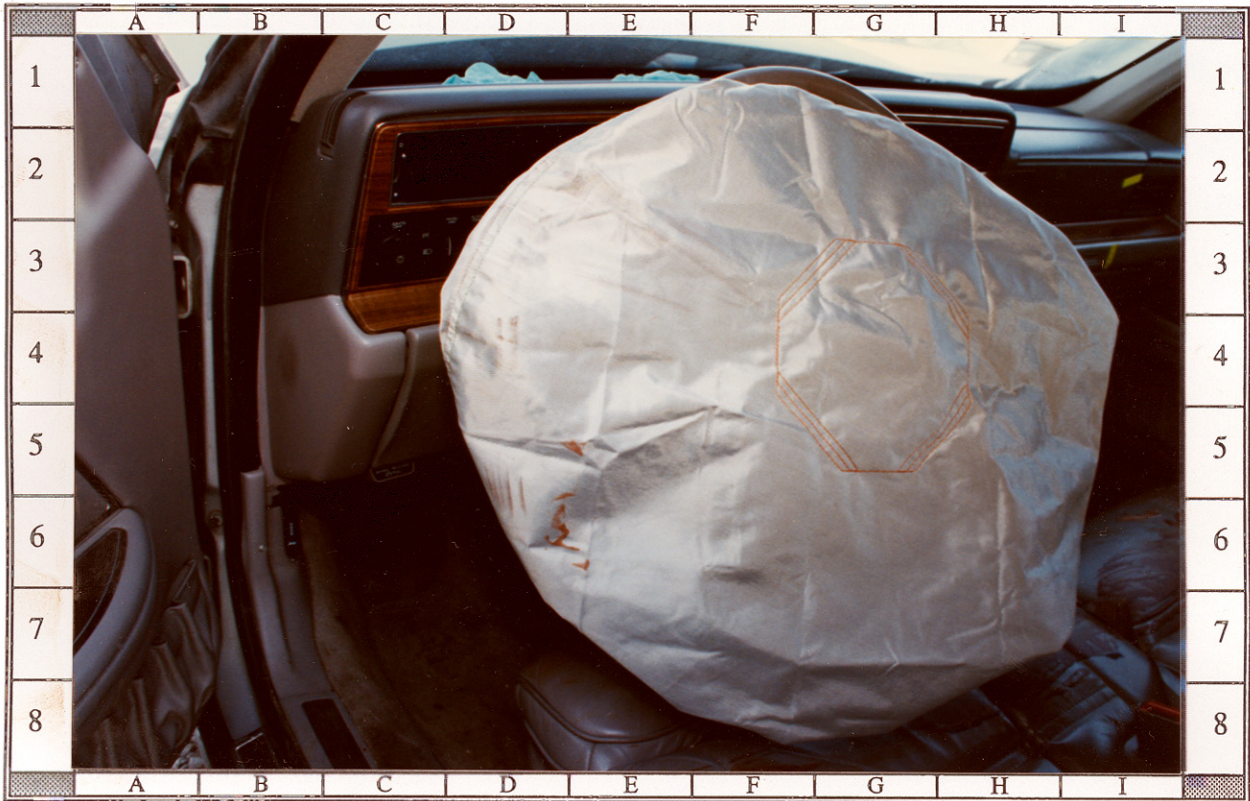
45 -- Closer-up of 1990 Lincoln Continental's deployed air bag showing blood on lower left of bag (cells D5--E6)

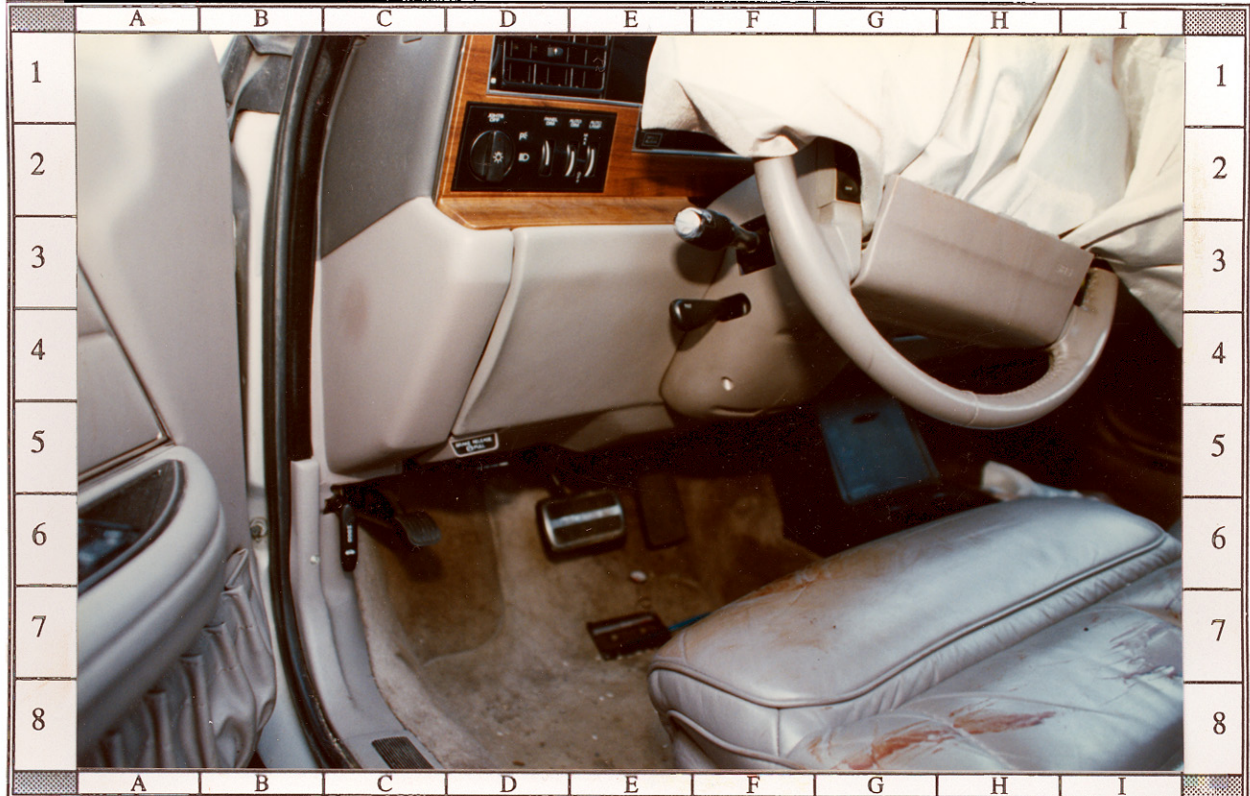
46 -- Close-up of 1990 Lincoln Continental's lower dash/knee bolster--no evidence of contact; see column tilt control & blood on seat

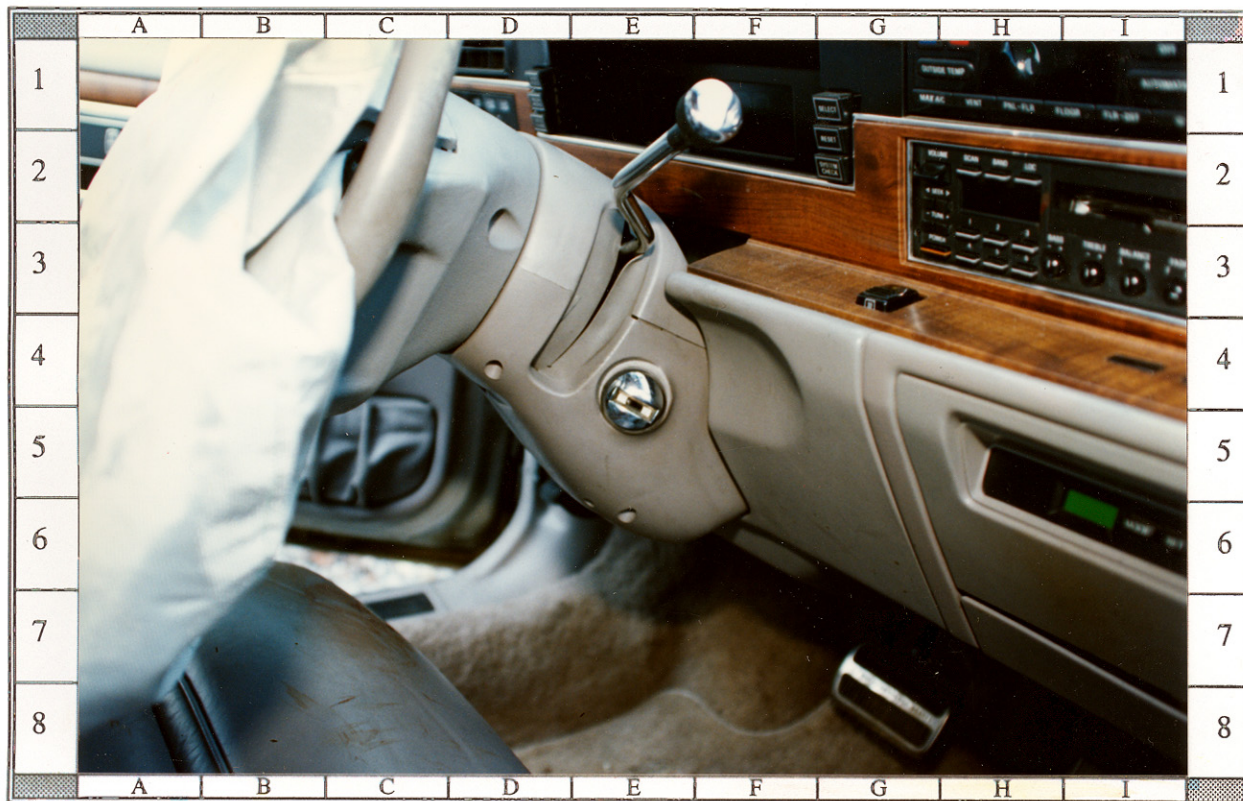
49 -- Close-up of 1990 Lincoln Continental's lower dash/knee bolster & steering column viewed from right--no evidence of contacts
